STATUE OF LIBERTY/ ELLIS ISLAND NATIONAL MONUMENT

> SEAWALL REPAIR ELEVATIONS

South of East Landing Pier (Shuttle Pier) Stations 3+21 TO 1+95

Prepared by: J.Lauletta-Weinmann August 2003 CONTRACT NO. Notes: 1. Station 3+21 northward towards East Landing (Shuttle Pier)
2. Station 3+21 = Station 12+59 (+/-) Reference 1982 As Built Dwgs.

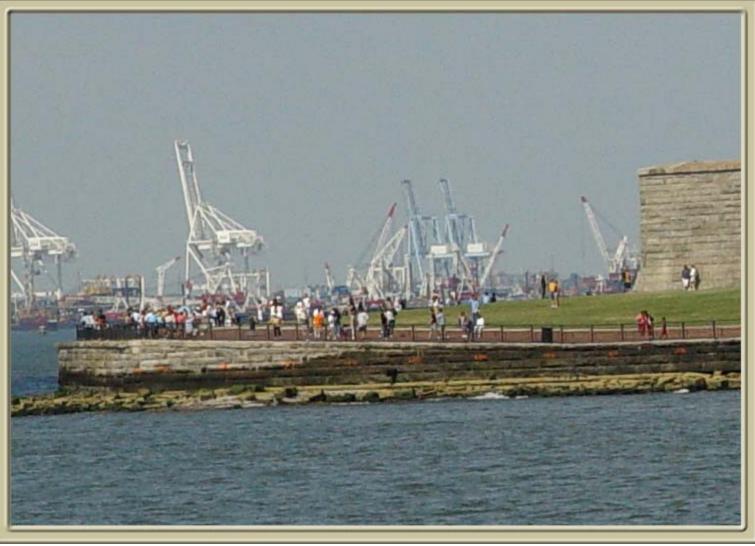
Sheet 2 of 8

- 1. The information presented on these sheets represents the results of a photo survey performed during July of 2003 and can only be considered as indicating the conditions existing at that time.

- 2. Hydroblast granite face stones to remove algae, moss, dirt and other contaminants. Hydroblast in and around joints to remove loose mortar and debris.

- 3. Hydroblast exposed concrete seawall to remove algae, moss, dirt and other contaminants at locations of displaced stones. Manually remove old grout and loose, disintegrated concrete.

- 4. If required, chip back to sound concrete at locations of displaced stones. Replace disintegrated concrete.
- 5. Repair broken granite inset stones.

- 6. Reset displaced and loose stones. Provide new horizontal epoxy coated tie anchors embedded into sound seawall concrete and resting in the mortar beds. Stones to be reset one course at a time. Shore as required.

- 7. Pressure grout only at hard to reach locations above the upper stones after the upper displaced stones are set.
- 8. Repoint the entire length of granite seawall face.

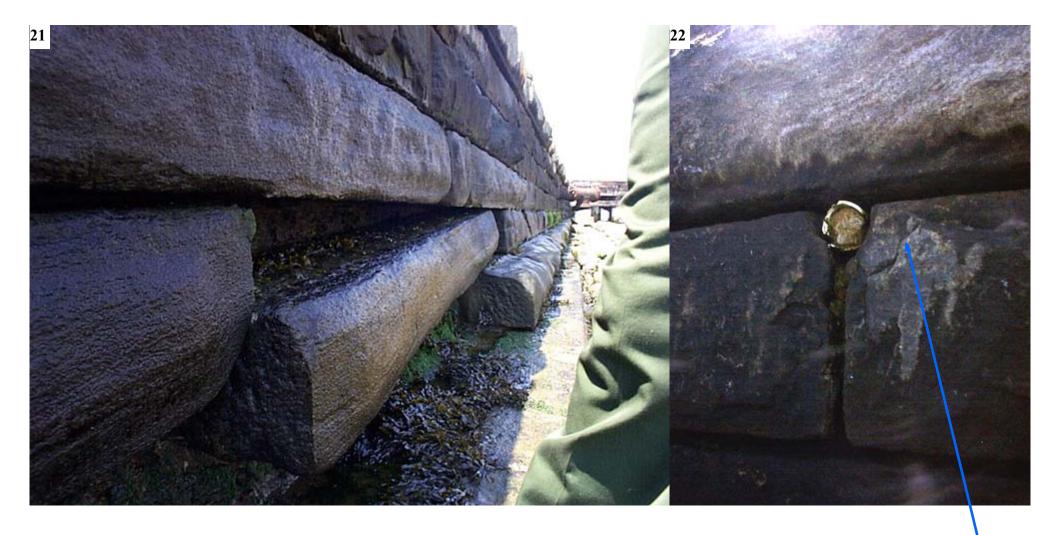
**Photo Detail - 6**

**Existing Grout Pipe**
